CASE STUDY

Australian Gas Networks & APA

**> FOCUSING ON PIPELINE
CONSTRUCTION
PRODUCTS USING
PRINCE2®**

APA recently completed a major project, (on behalf of AGN), by constructing a new 300mm diameter high pressure steel natural gas pipeline, a major feature of which included a 930-metre directional drill under the Brisbane River, in the city of Brisbane. The horizontally directional drilling operation included navigating riverbed formations, such as loose gravels, mudstone, and marine mud along with existing river features such as active jetty piles, river leases and remnants of a World War II destroyer wharf structure.

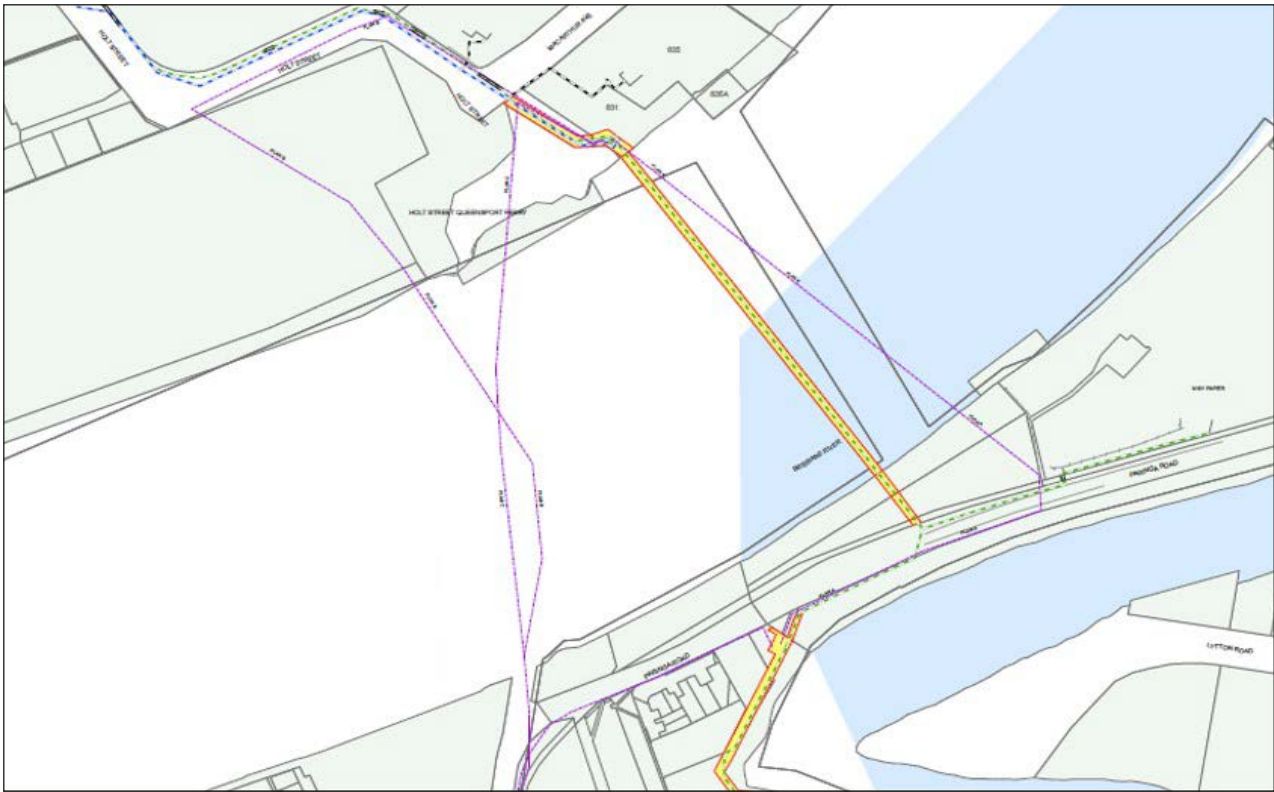
Figure 2.1 Concept for Brisbane River Crossing options 1, 2 and 3

With the preliminary station works completed by Summer 2016, the focus shifted to the new pipeline route with three options put forward for a discussion with the client, each of them with different costs and construction issues; they were also different in terms of risk to the security of supply from the existing pipeline crossing.

Detailed design progressed with the river design and was finalized in April 2018 as shown in Figure 2.1. APA group sought a third-party review, which the design successfully passed; this brought the successful completion of the first stage of the project.

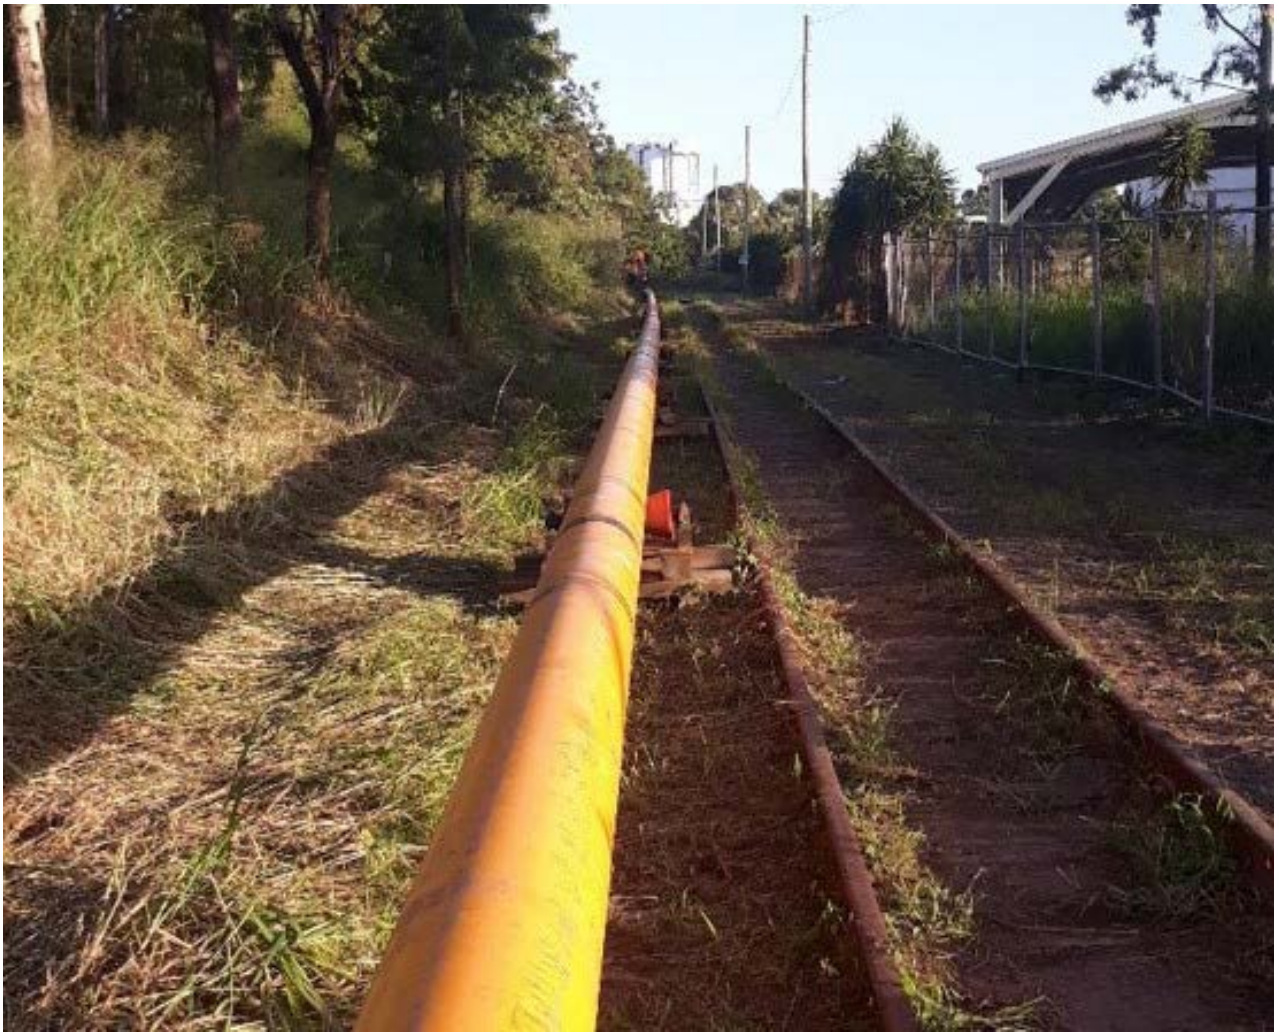
Figure 4.1 The right of way used for the HDD sting construction

- › Due diligence and accept design
- › Location of line pipe laydown
- › Location of HDD string construction and suggested construction techniques
- › Suggested option for crossing of road and large commercial drive
- › Field joint preparation
- › Field joint coating and testing
- › Pipeline gauge and hydro testing success factors
- › Consideration for pipeline ballast during pullback
- › 100% Non-destructive Testing (NDT) on bore string welds
- › 100% visual examination
- › Electrical drainage test post pull through to ensure coating integrity

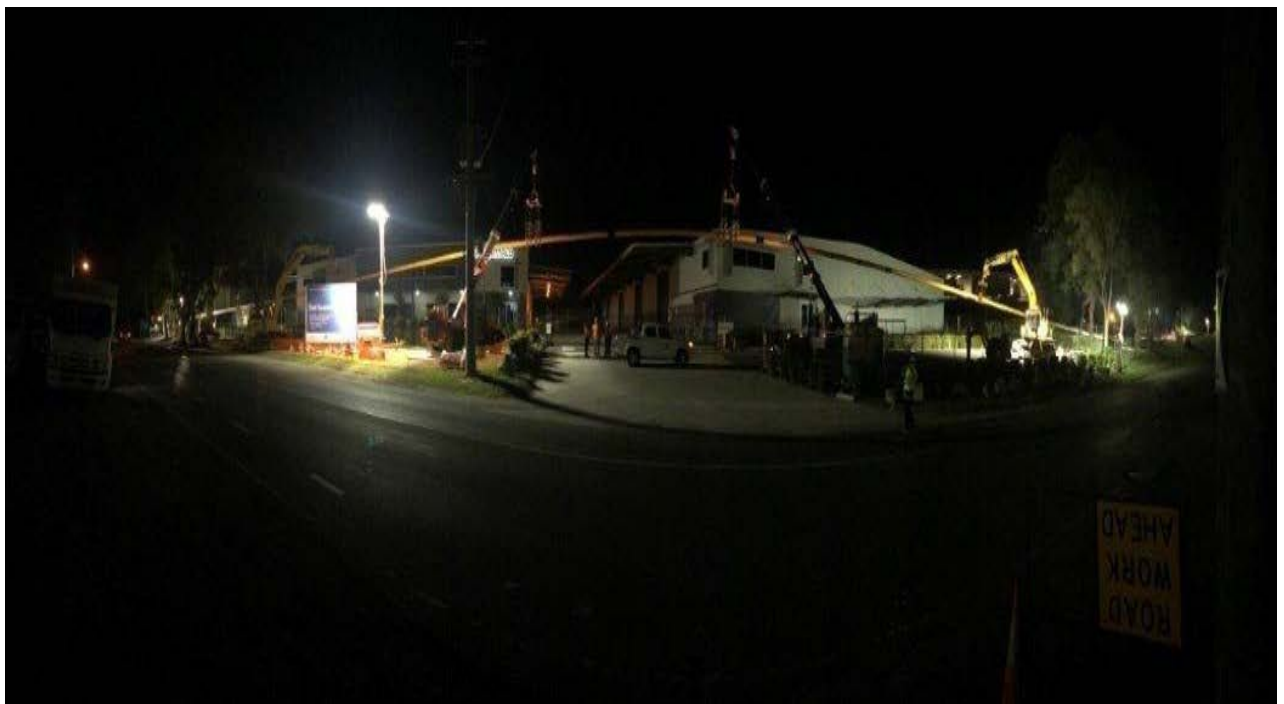
Figure 4.2 Sting elevation over commercial drive during pull back activities

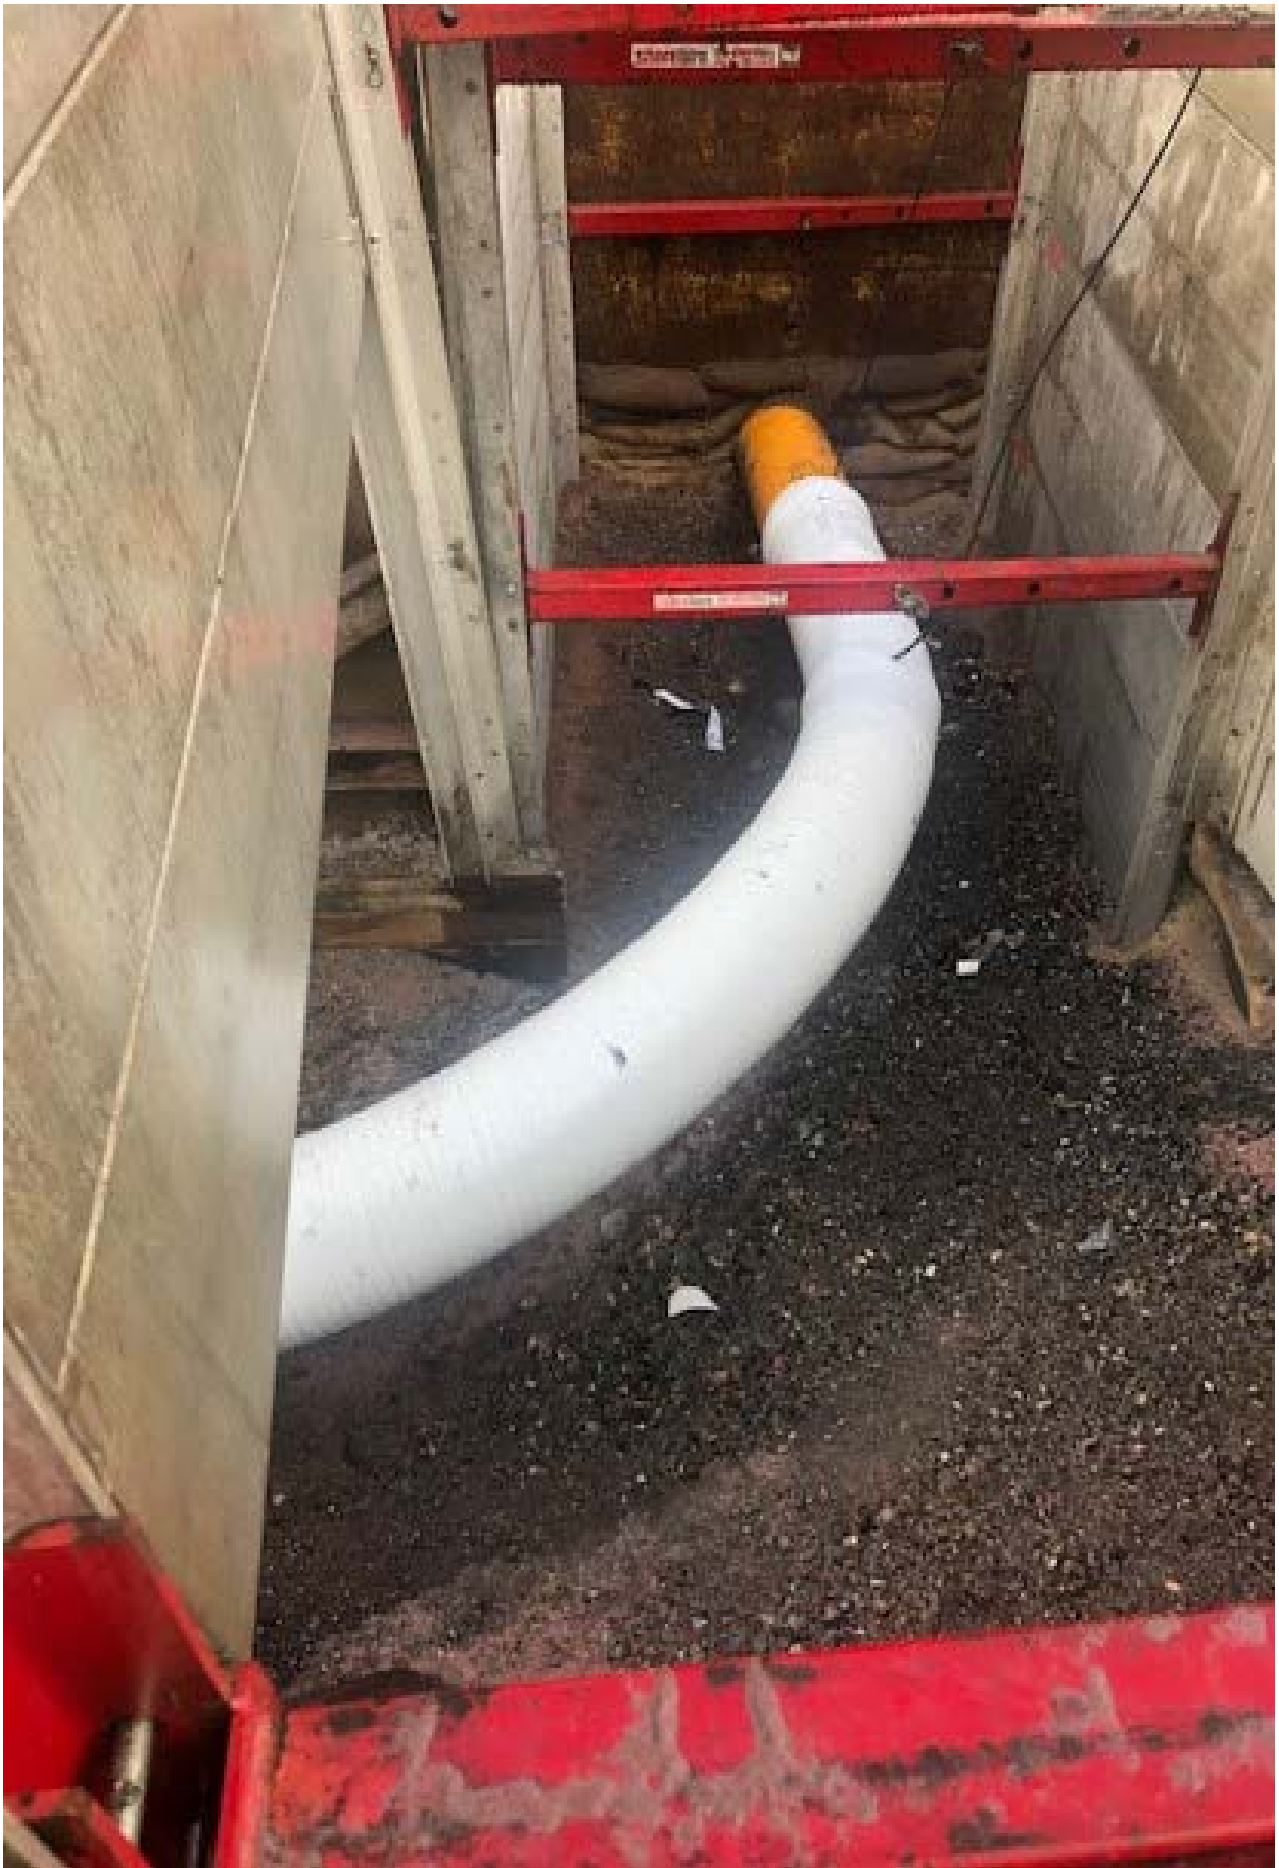
Figure 4.3 5 times diameter hot rolled induction bend installed with corrosion protection wrapping installed prior to backfill

- › 5 times diameter hot induction bends
- › Line pipe
- › Pipeline delivery receipt
- › Welding Non-Destructive Testing
- › Field joint coat preparation
- › Field joint wrapping and testing
- › Corrosion Protection location
- › PUP avoidance
- › Location of line pipe laydown
